Transcutaneous Electric Nerve Stimulator Induced Inappropriate ICD Shock

Naeem Al-Shoaibi, MBBS, FRCP(C), ABIM

Abstract. Inappropriate shock delivered by implantable cardioverter defibrillators due to electromagnetic interference is a well-known phenomenon. This case report is about a new source of interference from a transcutaneous electronic nerve stimulation unit. Although the artifact from transcutaneous electronic nerve stimulation and interference with appropriate function of cardiac pacemakers is well documented, adverse interaction with implantable cardioverter defibrillators has rarely been reported. This case present a patient in whom a transcutaneous electrical nerve stimulation (a unit created an electrical artifact that was interpreted by a trans-venous implantable cardioverter defibrillators as ventricular fibrillation), led to the delivery of inappropriate therapy. Transcutaneous electrical nerve stimulation units should be used with caution in patients with implantable cardioverter defibrillators.

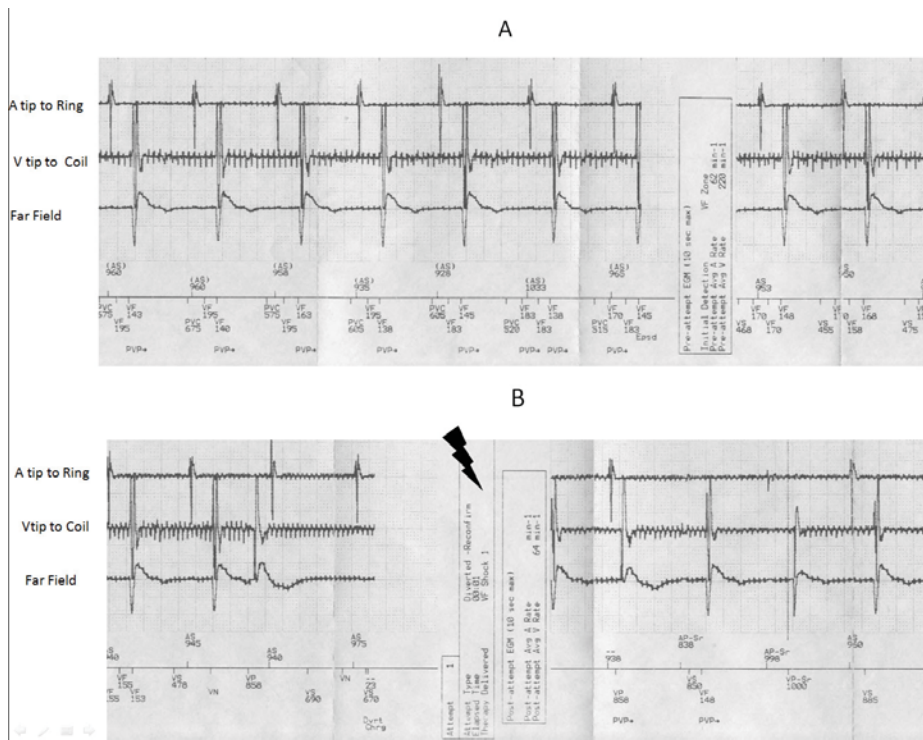
Implantable cardioverter defibrillators interrogation revealed inappropriate shock due to electromagnetic interference. High frequency electromagnetic interference (EMI) could be seen in all the channels of the ICD tracing (Fig. 1).

Fig. 1. A. ICD tracing showing features of electromagnetic interference from the chiropractic devices. All the channels (both near field and far field) show the artefacts: B. Delivery of inappropriate shock due to EMI.

Electromagnetic interferences could cause false sensing in implantable defibrillators. The devices used in acupuncture, electrocautery, diathermy, electrolysis, and TENS can cause this problem. Patients with ICDs should be cautioned about these interferences and should avoid exposure to these sources.
